**FINAL REPORT**

**CAMERON CREEK, SCHAFF AND DUNLAP PROJECT  
GOLDEN VALLEY COUNTY, MONTANA**

**MT A/E 88-46-124**

**JUNE 28, 1989**

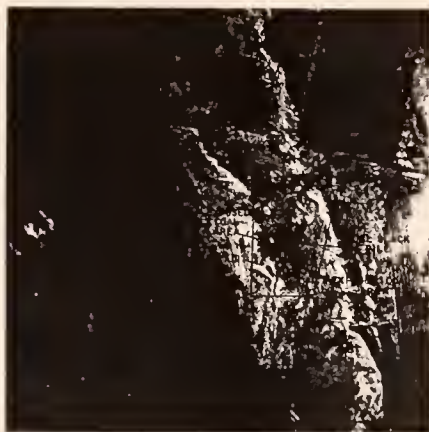
PICTURE 2 SHOWS THE ADIT ENTRANCE WHICH IS COVERED BY WOOD DEBRIS

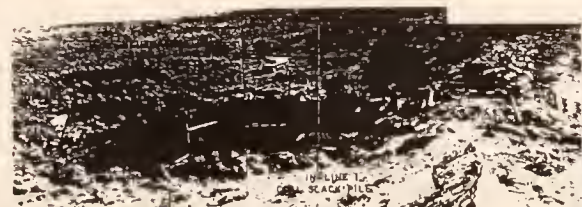
3. PICTURE 3 SHOWS INCLINES 1, 2 AND 3, THE OLD CABIN REMAINS, THE COAL SLACK AREAS, AND THE SCATTERED DEBRIS

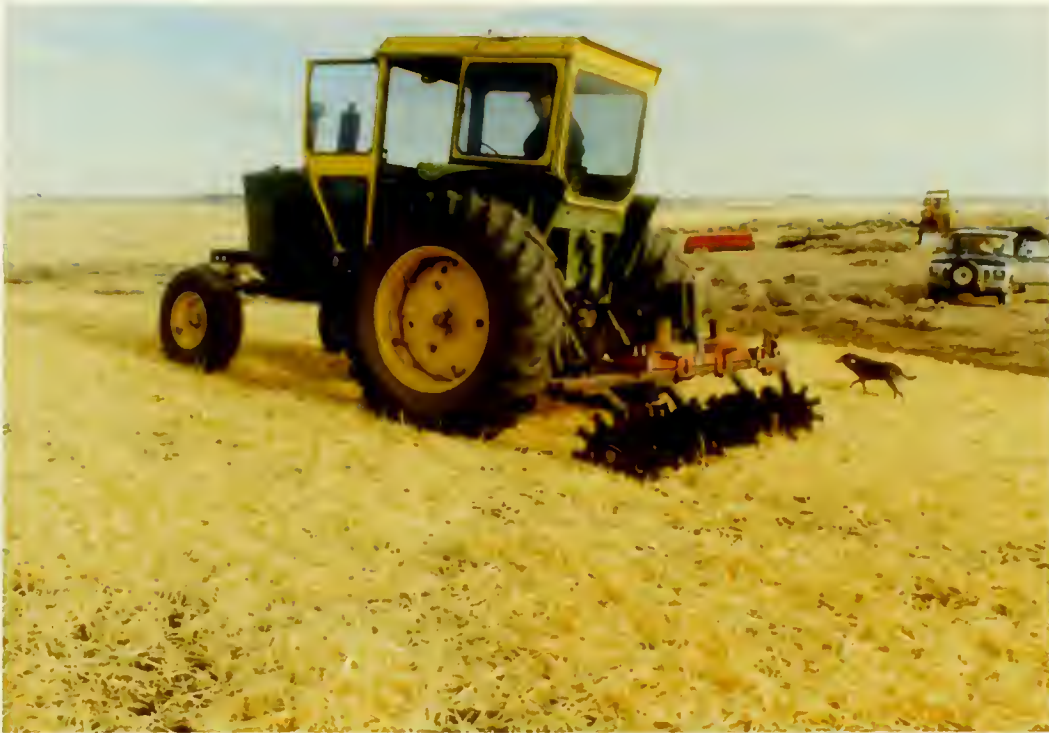
DUNLAP: Crimping the Incline Number 1 coal slack area with a John Deere tractor and homemade crimper.

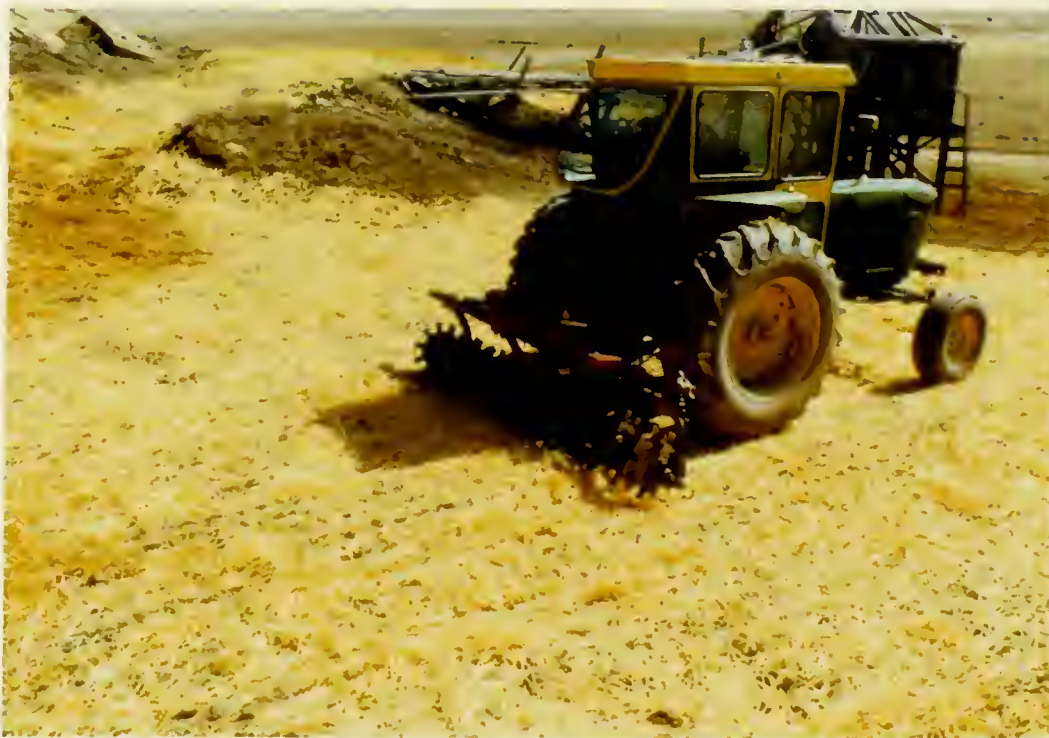
CAMERON:  
CREEK Crimping the borrow area and burn pit behind the loadout structure left at SHPO's directive.
